UNITED STATES ENVIRONMENTAL PROTECTION AGENCY
REGION III
1650 Arch Street
Philadelphia, Pennsylvania 19103-2029

Re: Request for Information Pursuant to Section 3007(a) of the Resource Conservation and Recovery Act, 42 U.S.C. § 6927(a), Regarding Generation and Management of Hazardous Waste by Akzo Nobel Coatings Inc.
EPA ID No. VAD000019828
Reference No. C06-003

Comprehensive Compliance Monitoring and Enforcement Report

AKZO Nobel
Roanoke, VA
VAD000019828

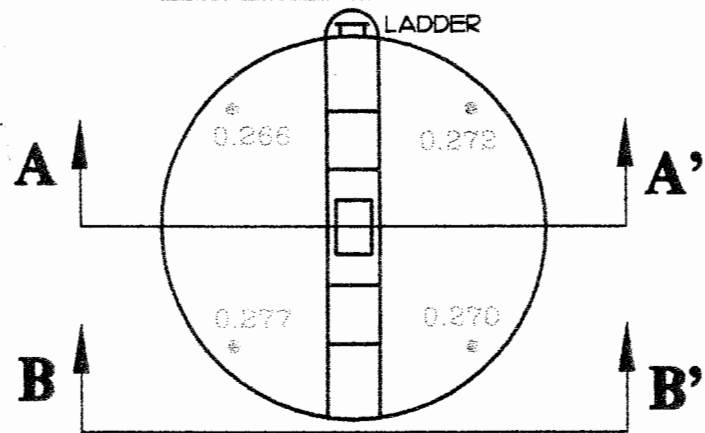
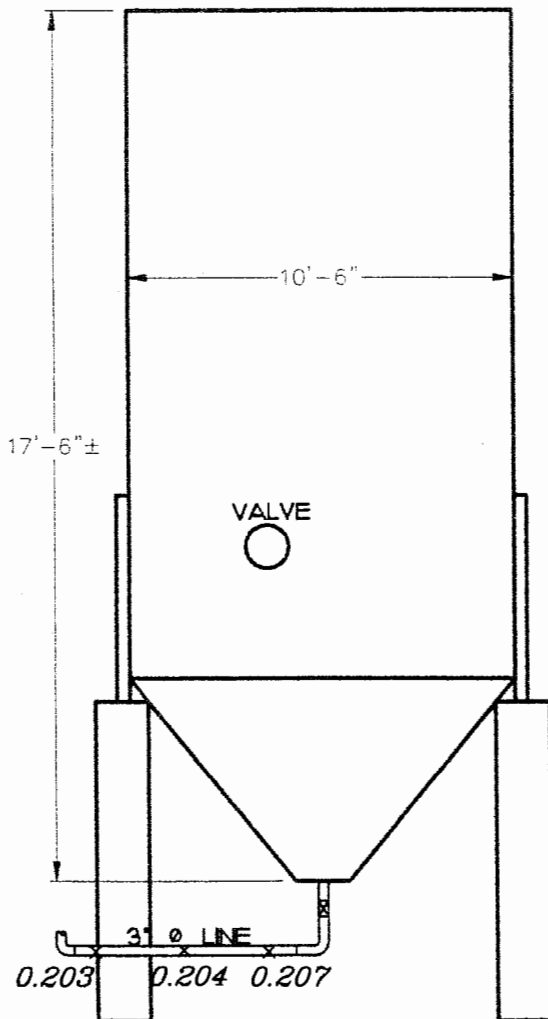
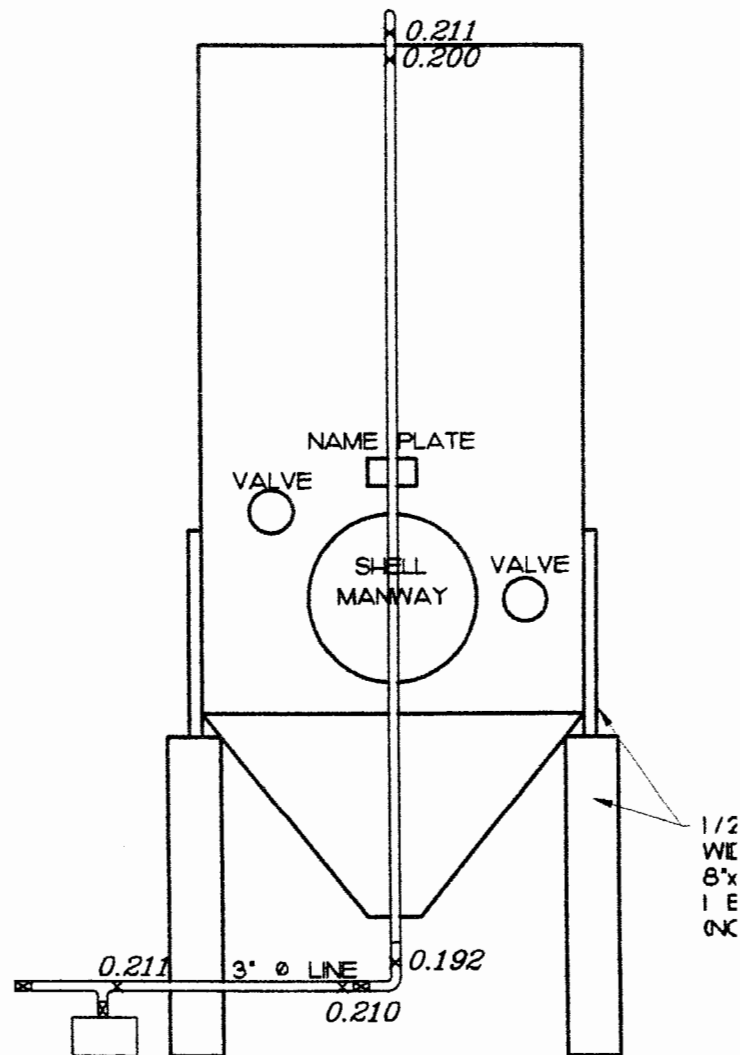
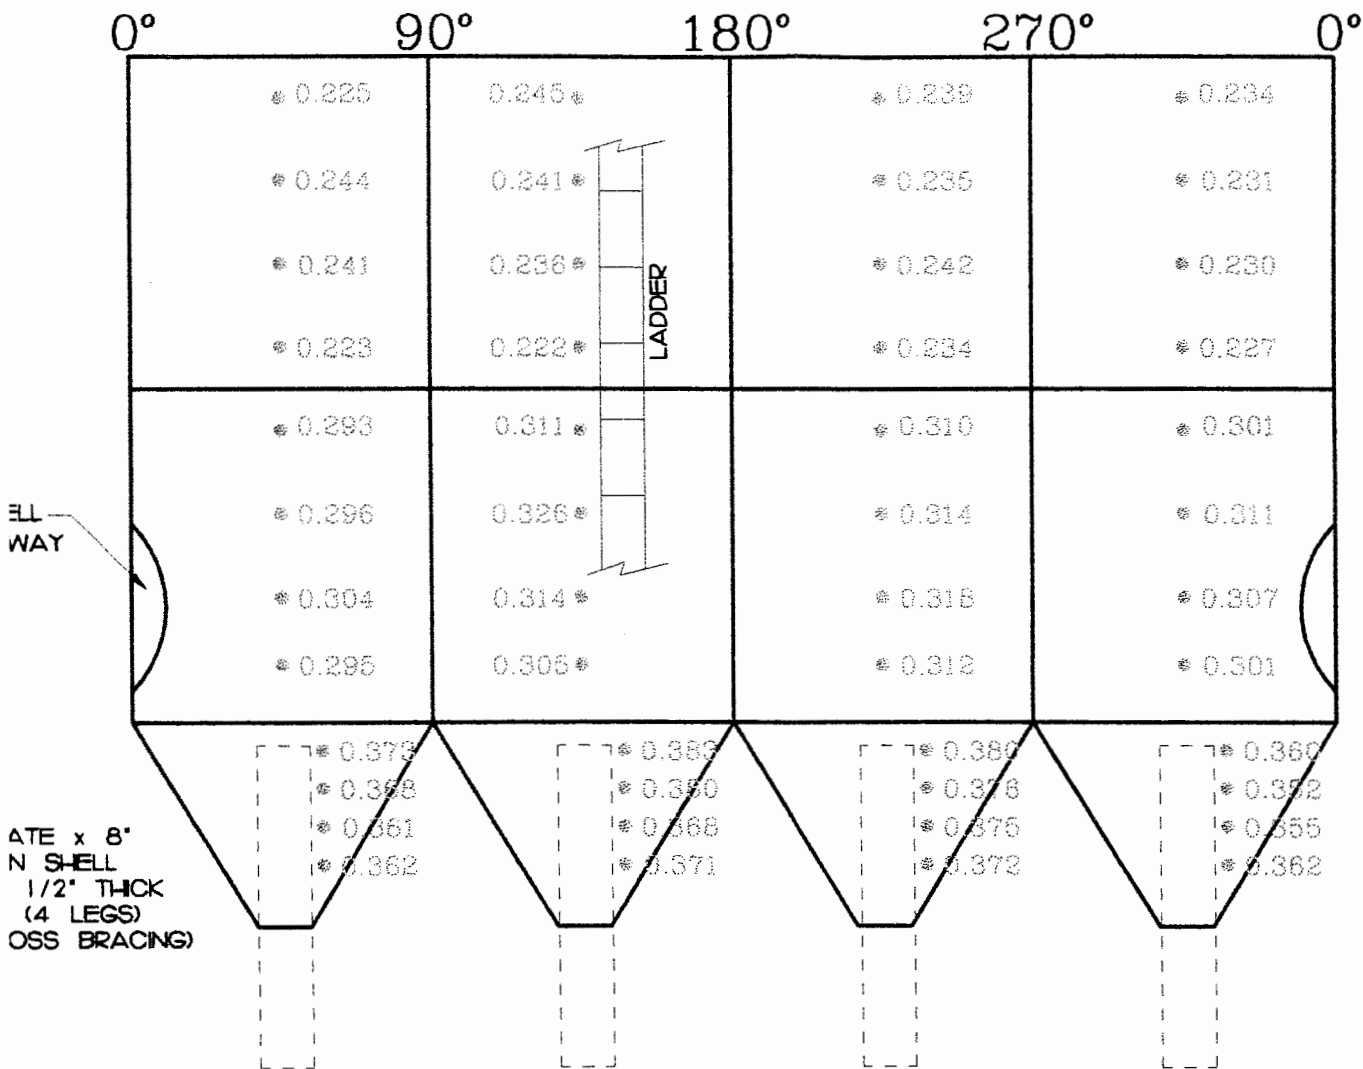
SHELL AND CONE THICKNESS

✖ 0.21
✖ 0.19

ALL LOCATIONS ARE APPROXIMATE.
